Inlet Guard
City of Garland Pilot Program
July 2nd – August 4th 2014

Drafted by Kim Bishop
Date: August 6, 2014

Pilot Program Report

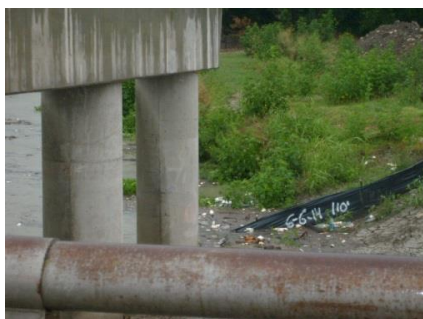
Miller Road Bridge
Garland, Texas
July 16, 2014

Below are photographs of debris from sewer run-offs that have accumulated in city creeks and along with polluting the environment, can also pollute a city's drinking water.

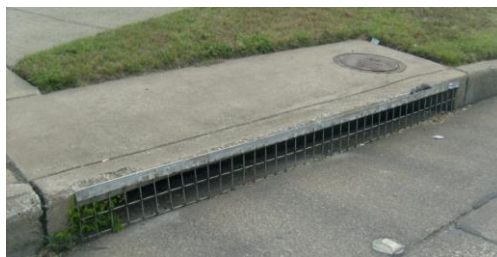
July 7th

(Note: Due to this being an older inlet, on-site modification was conducted to fit the pre-made screen onto the curb side inlet. The spacers were removed. This also allowed us to see the importance of the spacers.)

This inlet shows the importance of having spacers to allow for grass clippings and small debris to get from the street into the basket.

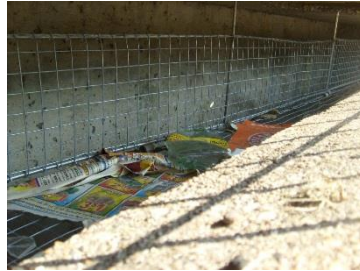
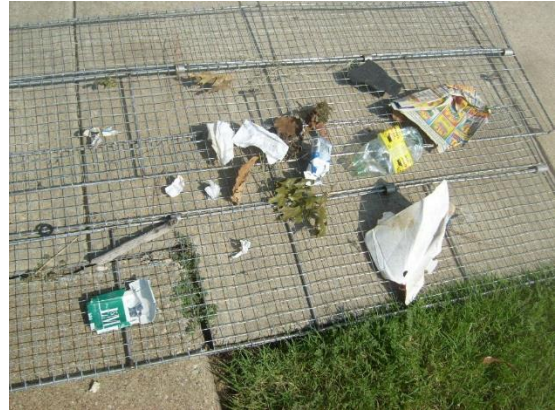
August 4th

The entire time, the street was clean. All debris was deposited into the basket, including large pieces as shown in the picture on 8-4-14.

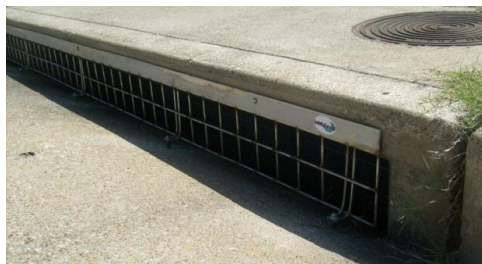
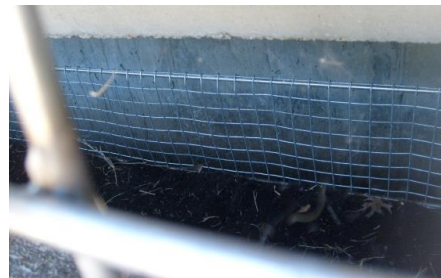
July 7th

(Note: This is the only inlet that a filter was inserted in the basket. The filter is a hair mat, provided by 'Matter Of Trust'. Hair mats are natural absorbents of oil and are biodegradable.)

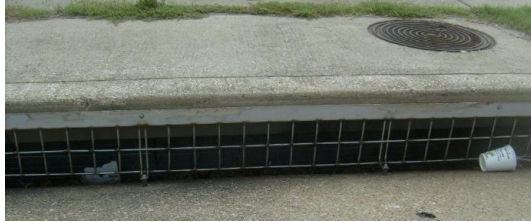
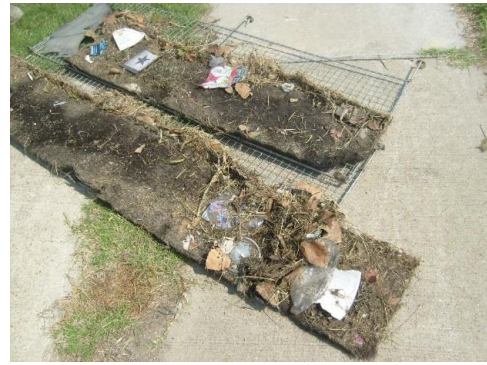
August 4th

In this inlet with the hair mat, it was easy to see the trash collected as well as grass clippings and twigs. No oil seemed to be in the mat, however, if there had been oil in this inlet, we would have been prepared. (*Special Thanks to 'MatterOfTrust.org'*)

During rainfall, neither the screen, nor the hair mat impeded the flow of water into the city sewer system. We would recommend the hair mat filter in all baskets, as a way to catch oil and small debris such as grass clippings.
