## REPORT OF RESULTS USING “BOOMS” DEVICES IN LAKE VILLARRICA, CHILE

*This report was developed on October 28, 2023 by Mattia Carenini, COO of Fundación Matter of Trust Chile and Global Hub Manager of Matter of Trust Inc Public Charity, with the advice of Mirta Paredes, CTO of Fundación Matter of Trust Chile*

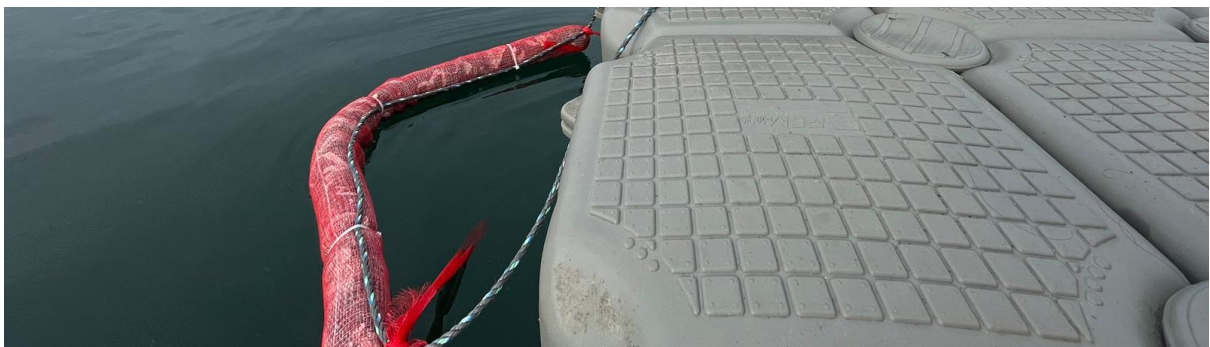
Device #1 (a 932 g Boom of human hair covered in cotton and polypropylene) was installed on the municipal floating dock in Villarrica, attached to the dock on the left side, held in place with a 8mm polypropylene rope.

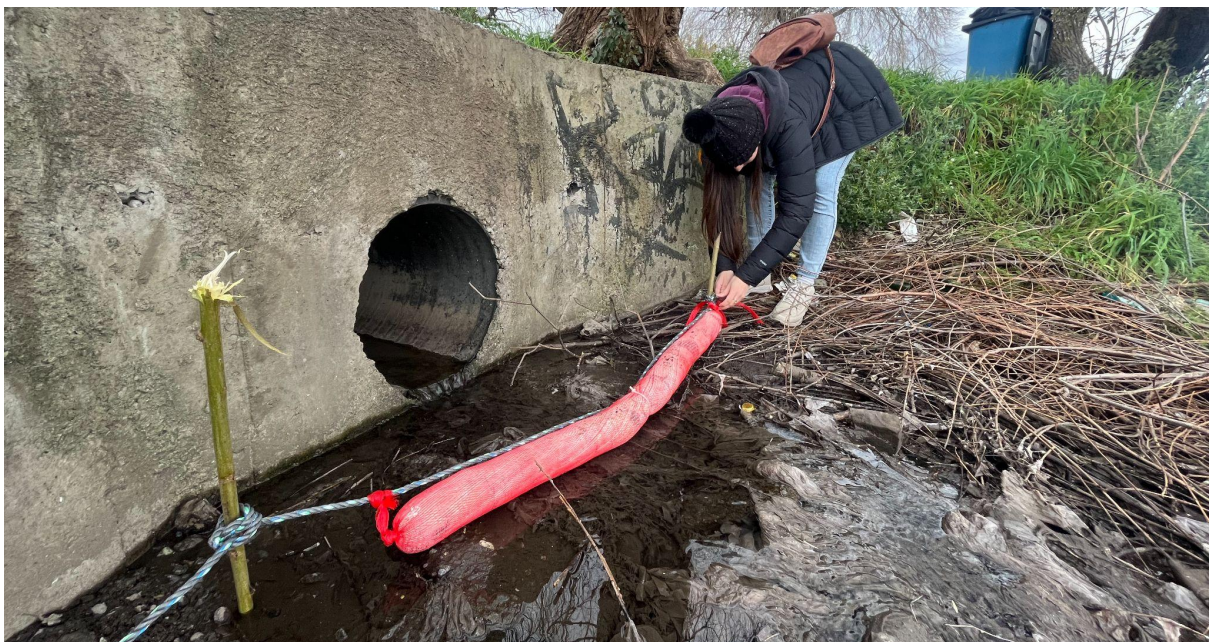
Device #2 (a 748 g Boom of dog fur covered in cotton and polypropylene) was installed in a water outlet, in the “El Lanchón” sector, an area where unauthorized discharges of sewage are carried out, as evidenced in photos, due to the presence of toilet paper. The device is installed perpendicular to the water flow and is secured with a polypropylene rope.

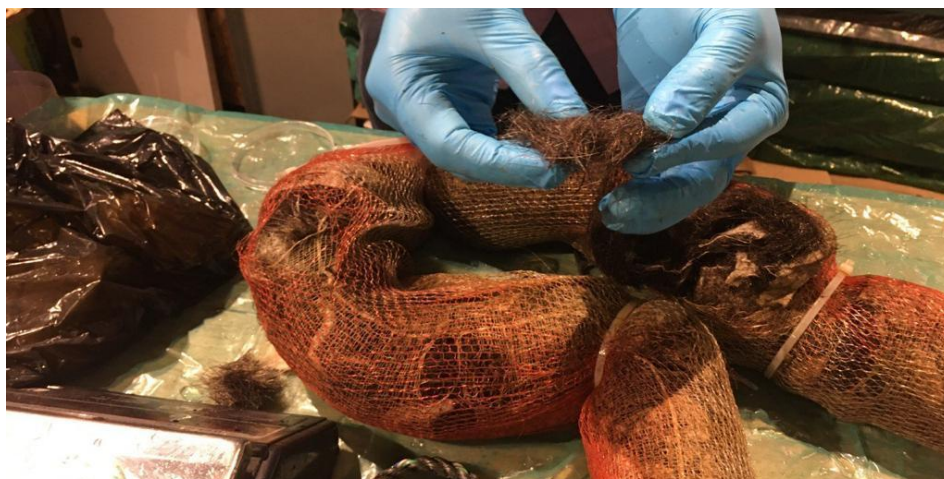
Device #1 doesn't present any visible damage in its polypropylene cover. Weighing is carried out after drying, registering a weight of 4055 grams. Samples are taken for analysis

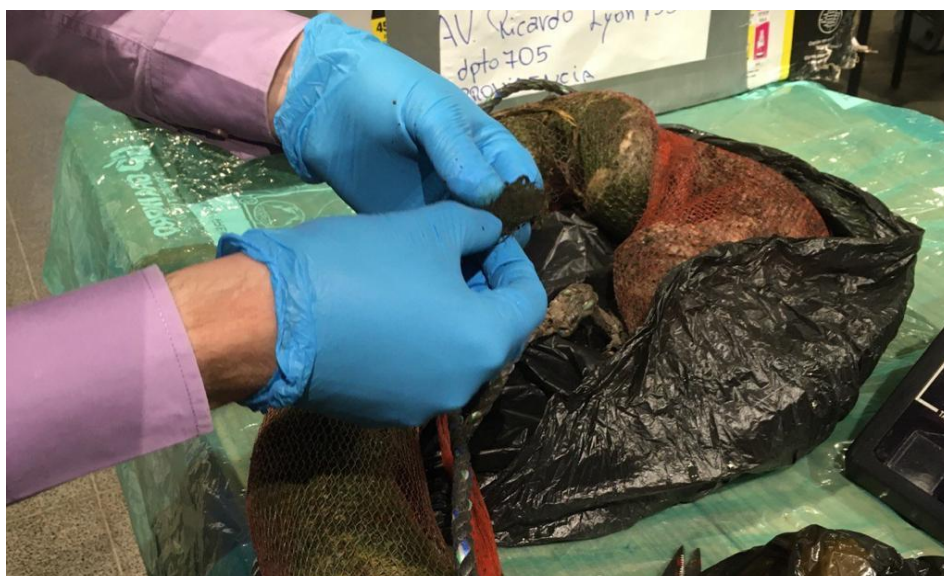
Device #2 doesn't present any visible damage to the polypropylene cover, however the device was moved by unknown persons, leaving it next to the water outlet, parallel to the water flow. The boom registers a green shadow on its surface, evidencing macroscopic growth of photosynthetic organisms. Samples are taken and weighed, recording a weight of 2730 grams.

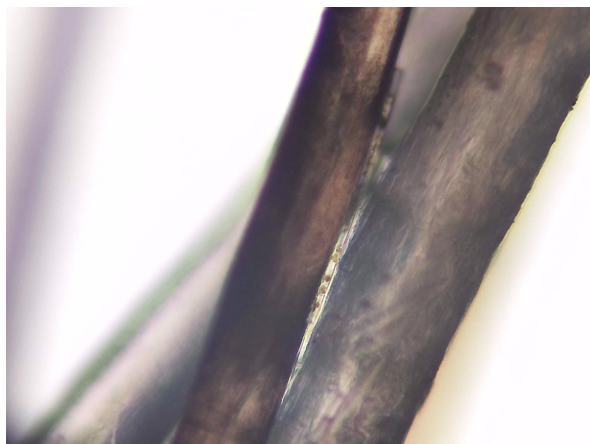
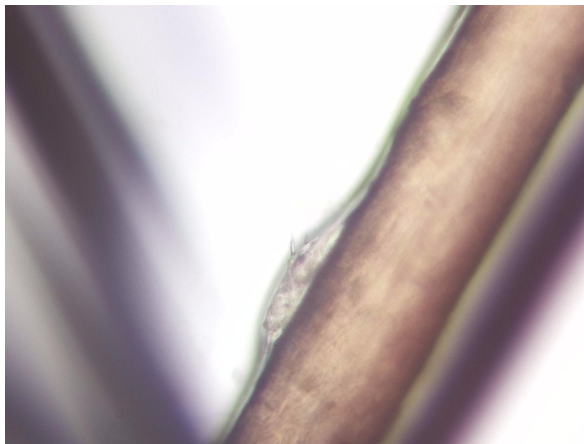
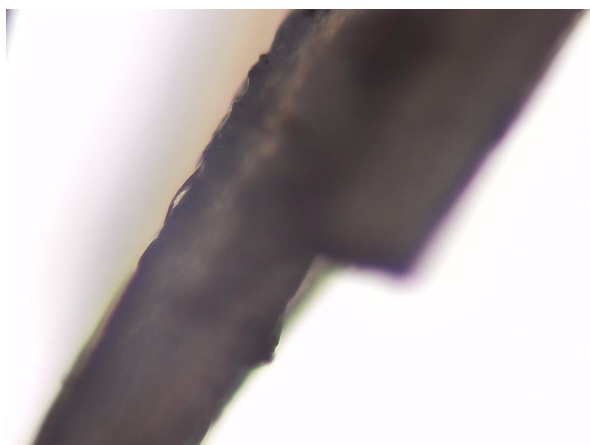
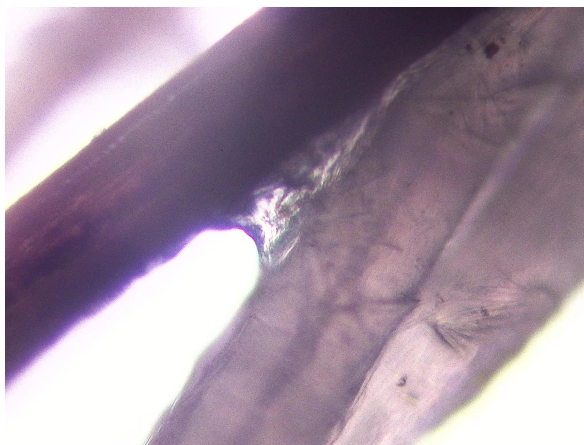
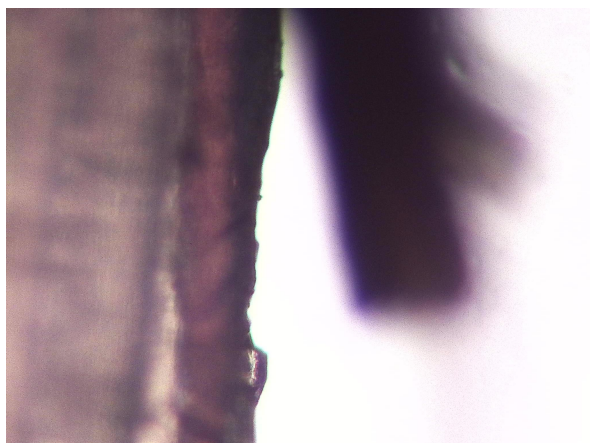
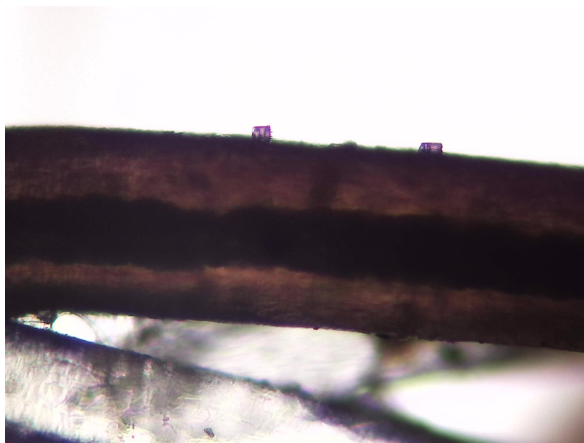
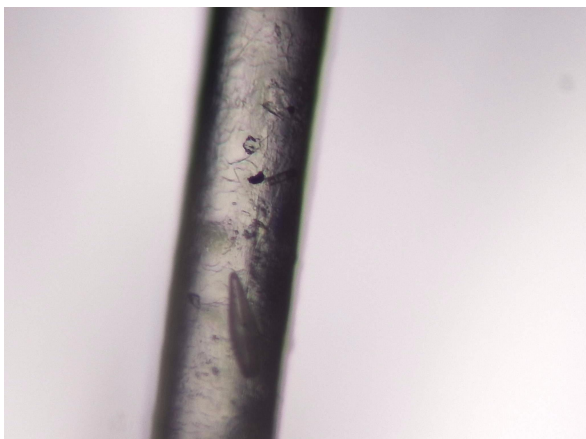
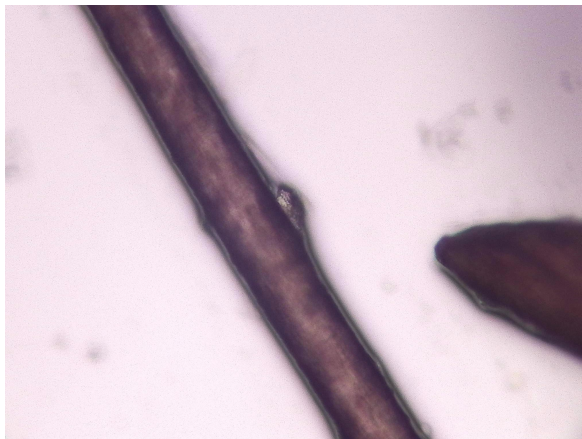
## MICROSCOPY STUDY ON DEVICE #1 (DOCK)

Sample #1 (dock) retained a total amount of 3123 grams of contaminants during the 52 days of exposure. In the photographs (microscope) hydrocarbons, oils and charcoal were found adhered to the surface of the hair. Contaminants were held continuously and were removed from the environment.

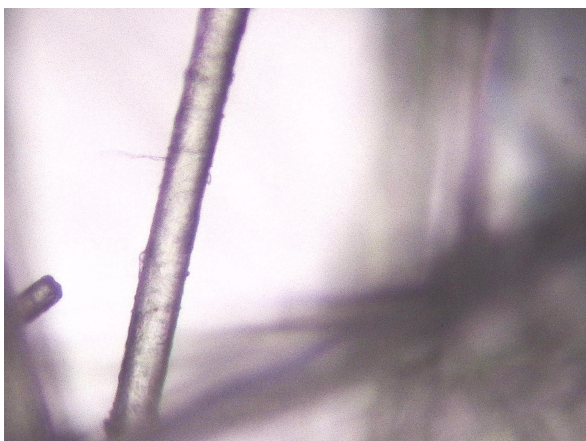
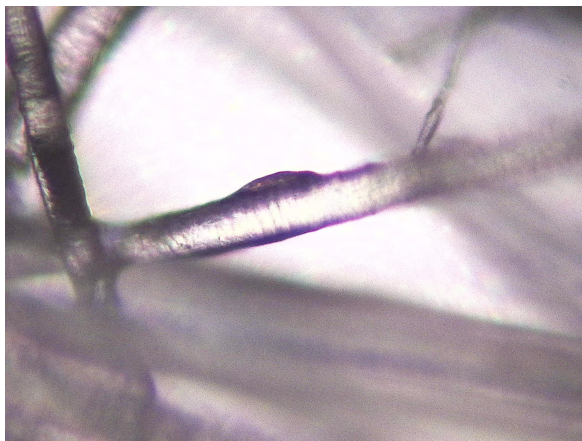
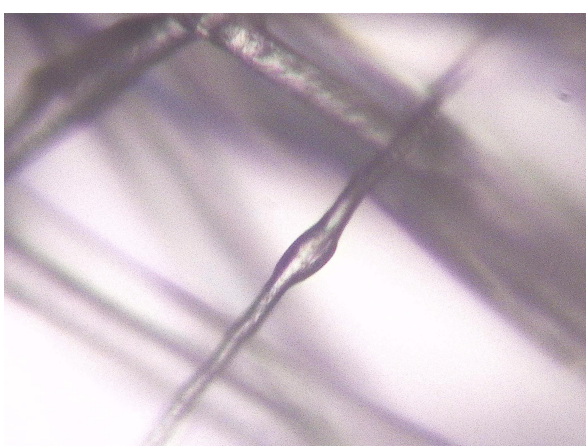
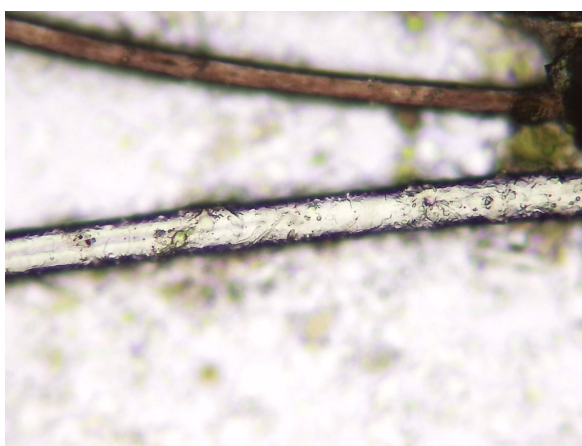
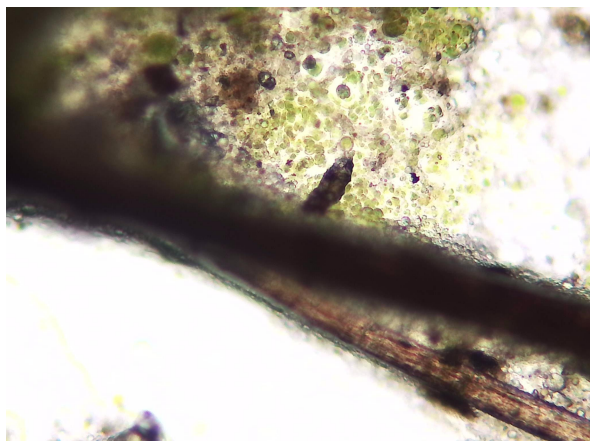
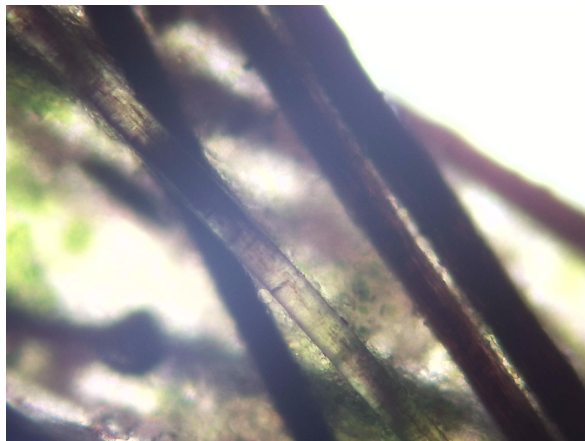
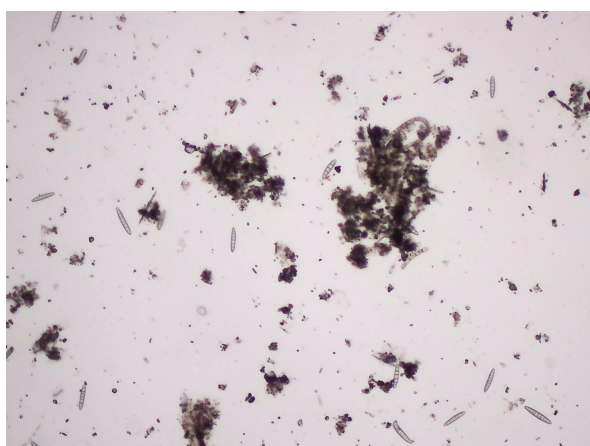
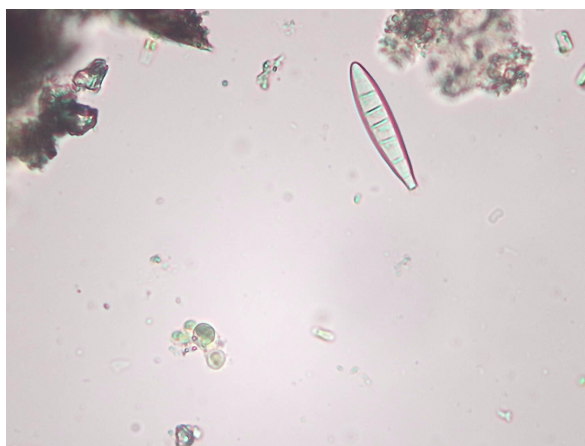
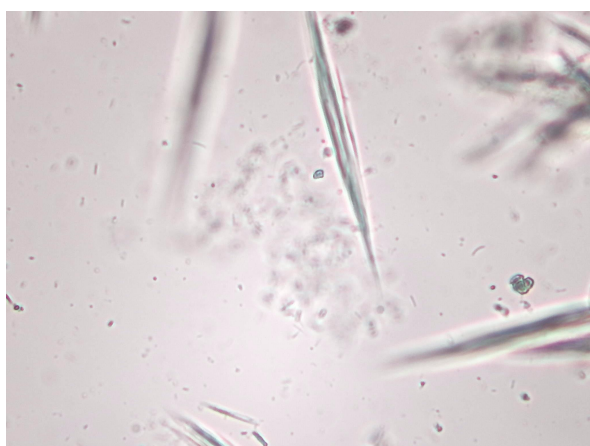
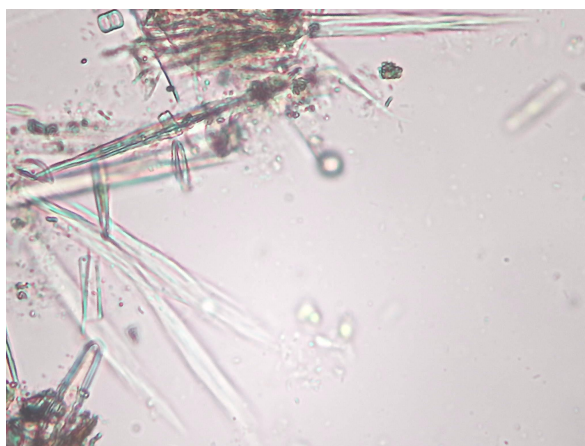
### **MICROSCOPY STUDY ON DEVICE #2 (WATER OUTLET)**

Sample #2 (water outlet) retained a total amount of 1982 grams of contaminants, during the 52 days of exposure. Hydrocarbons and oils were found adhered to the Boom, however the sample presents a much greater amount of “sludge” type contaminants.

This is organic material from sewage, which remained adhered to the surface of the hair, capturing the excessive nutrients before they reached the lake. In this way, a development of algae (both diatoms and cyanobacteria) was recorded in the device.

The sample also recorded the presence of coliforms.
